Draft
Site Visit Report
Coalbed Methane Landowners and
Environmental Impacts
Gillette, WY

Eastern Research Group, Inc.

October 11, 2001

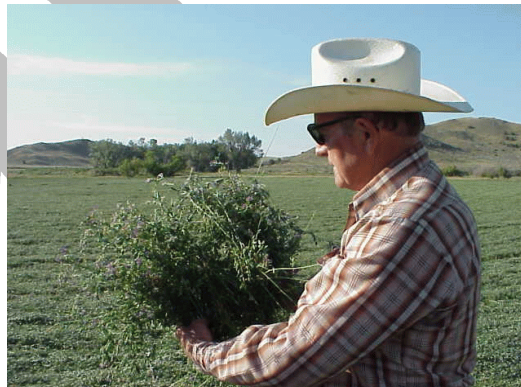
Mr. Swartz is a third generation rancher near Gillette, Wyoming. He typically raises 350 head of cattle on 15,000 acres, 12,000 of which are deeded. Currently, Mr. Schwartz is raising 260 head of cattle due to drought and loss of feed. He runs a cow/calf operation and sells off his calves every year. Over the years, Mr. Swartz has invested approximately \$100,000 to construct livestock watering stations for his cattle. He also maintains 285 acres of meadows where he grows alfalfa and other forage crops. Currently, 120 acres are producing alfalfa. Figure 1 shows a picture of Mr. Swartz holding some of his alfalfa. Mr. Schwartz uses flood irrigation when water is available to irrigate his meadows. He is currently not using this technique due to the detrimental effects of coal bed methane produced water on his fields. Mr. Swartz believes his alfalfa grows well because the long roots of the alfalfa plants are able to tap into a shallow aquifer that runs below the meadows. This aquifer is recharged in part from Wildcat Creek that runs through Mr. Swartz's property. Figure 2 shows a picture of Wildcat Creek. Wildcat Creek eventually flows into Horse Creek.

Figure 1: Alfalfa Meadows at Swartz Ranch

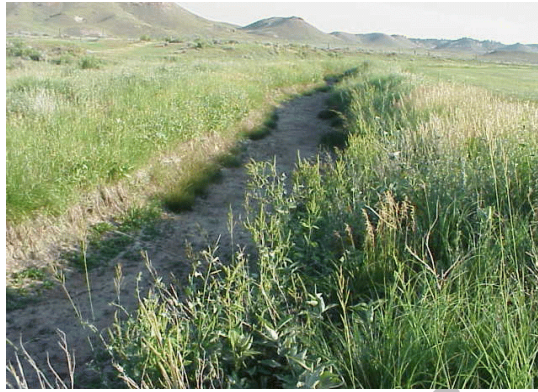
Figure 2: Wildcat Creek at Swartz Ranch

Over the past two years Mr. Swartz believes that Wildcat Creek has changed significantly. Native vegetation in and around the creek bed has died, the sides of the creek bed have changed due to erosion and/or slumping, and different species of vegetation such as slew grass and cat tails are becoming more prominent in the creek bed. Figure 3 shows a picture of the influx of slew grass in creeks with CBM discharges in the Gillette area. Mr. Swartz believes these changes are caused by the discharge of CBM produced water upstream from his property. The CBM water only flows through his property during the winter months when the ground is frozen and the rate of infiltration is lower. Before the CBM wells were installed Mr. Swartz stated that Wildcat Creek would flow one to two months during the spring and contribute to the recharge of the shallow aquifer below his

meadows. Now, with the CBM discharges to the creek the water flows for five to six months including winter months when the ground is frozen. The increased water flow, the high salinity of the produced water, and influx of water during months when the creek is typically dry has killed most of the native grasses that typically grow in the creek bed during the spring and summer months. Figure 4 shows a picture of the current creek bed. Mr. Swartz stated that he relies on the vegetation in the creek bed to feed his cattle during the winter months. The salt tolerant slew grasses that have replaced the other grasses in the creek bed are not palatable and therefore not eaten by his cattle. This loss of feed has required Mr. Swartz to increase the amount of supplemental feed that he purchases to feed his cattle. Mr. Swartz is extremely concerned that the CBM water will contribute to the recharge of the shallow aquifers below his meadows and increase the salinity of the water. The alfalfa that Mr. Swartz grows is a salt sensitive plant and an increase in the salinity of the water below the meadows may kill his crops. Mr. Swartz believes that, according to the Montana Department of Environmental Quality, the water discharged from each CBM well during a year contains up to 20 tons of salt. Without the forage crops from his meadows, Mr. Swartz does not believe his ranch will survive. He is able to grow a ton of hay/alfalfa for approximately \$20 per ton. Due to the drought in Wyoming and surrounding areas for the past several years, the cost of hay is up to \$100 per ton. Mr. Swartz indicated that he needs approximately 500 tons of hay per year to feed his cattle.

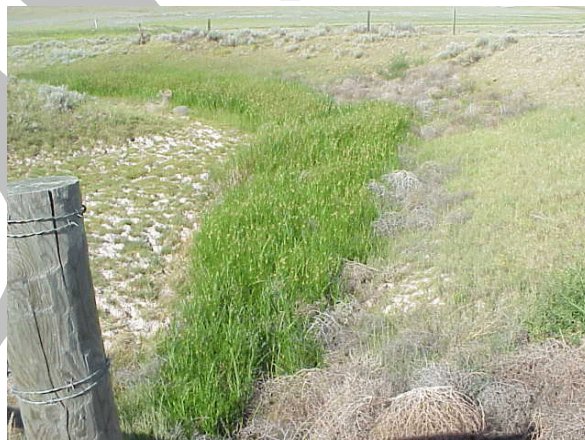
Figure 3: Slew Grass

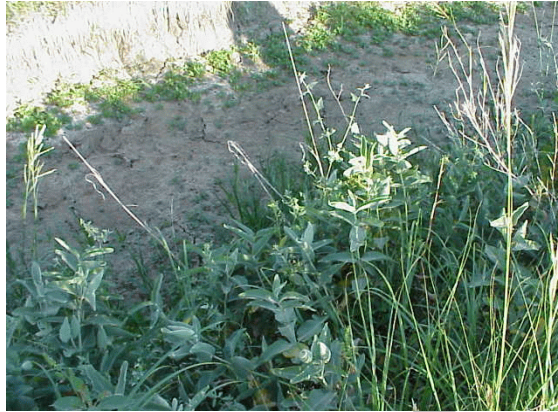
Figure 4: Close-Up of Wildcat Creek at Swartz Ranch

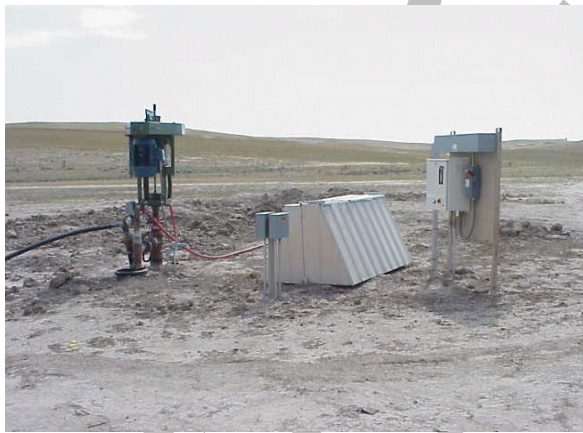
A large number of the wells at this location were not working and in some instances aboveground water lines were installed and discharges were occurring at non-permitted outfalls. Mrs. Sorenson indicated that standing water from such discharges increases the leaching of salts from the soils to the surface which can kill vegetation. This non-permitted discharge had been occurring for a few days. Figure 5 shows a picture of one of the aboveground water lines from a CBM well with a progressive cavity pump. Figure 6 shows a picture of a non-permitted discharge from the aboveground water line. Figure 7 shows a picture of the standing water associated with the non-permitted discharge.

Figure 5: Aboveground CBM Water Line at Sorenson Ranch

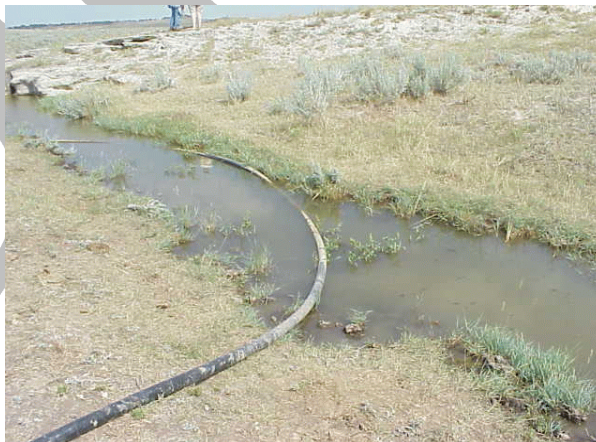
Figure 6: Non-Permitted CBM Discharge at Sorenson Ranch

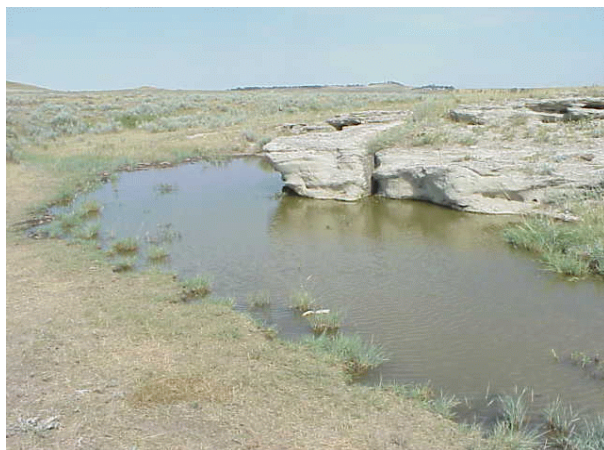
Figure 7: Standing CBM Water at Sorenson Ranch

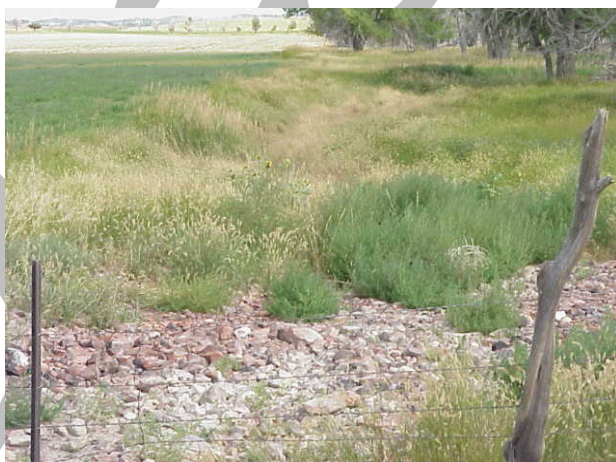
At another location on the ranch, Mrs. Sorenson stated that CBM discharges a few months ago killed vegetation in a creek bed. She believes the sodium adsorption ratio (SAR) of the CBM produced water on her land is about 20. The discharges from the well on the Sorenson ranch have caused areas of dead vegetation on the ranch and on neighboring property. Figure 8 shows a picture of the area of dead vegetation downstream on neighboring property. The outfall is located at the bottom of the picture.

Figure 8: Dead Vegetation at Neighboring Ranch

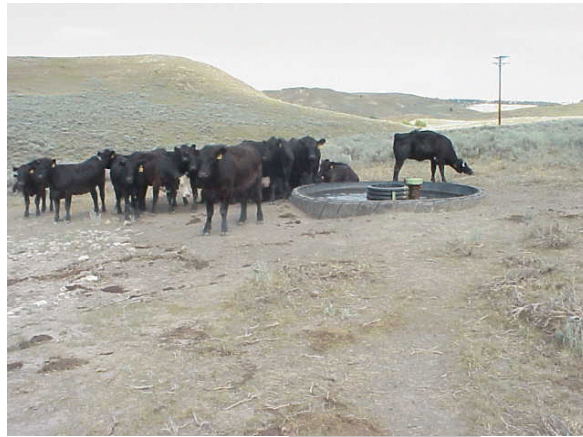
each watering station thereby allowing more land to be grazed during the summer months when water is scarce. Figure 9 shows a picture of a tire tank being used as a livestock watering point. Overflow from the tire tank is piped underground to a permitted discharge where the water flows down a concrete channel and over limestone rocks to precipitate the iron and minimize erosion. Figure 10 shows a picture of a permitted outfall at the Sorenson Ranch.

Figure 9: Tire Tank at Sorenson Ranch

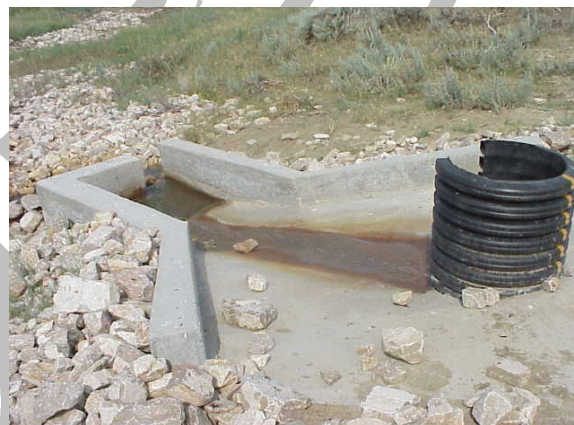
Figure 10: Permitted Outfall at Sorenson Ranch

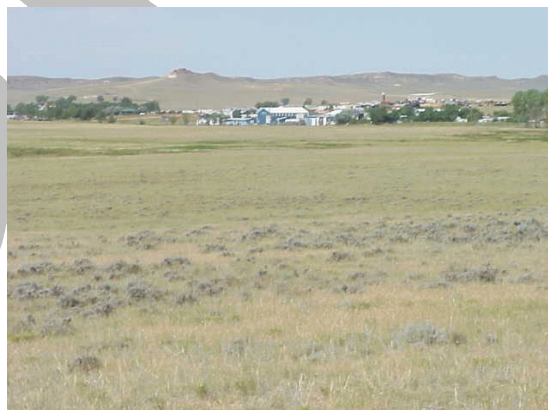
During the last few years Mr. Hoy has experienced a number of problems that are believed to be a result of the nearby CBM and coal mining operations. In 1999, Mr. Hoy installed a new leach field on his property due to the failure of an existing field that was installed in 1985. The old field became filled with water and could no longer accept effluent. When the old leach field was installed, groundwater was encountered at a depth of 17 feet. In 2000, the depth to groundwater in this area was measured at 31 inches. Due to the high groundwater level, Mr. Hoy had to install his new leach field in higher ground further away from the trailer park. The rising groundwater level is believed to be caused from the discharge of CBM water into the Little Rawhide Creek drainage which flows through Mr. Hoy's property. The excess water in the drainage has infiltrated the shallow sands that under-lie Mr. Hoy's property. Figure 11 shows a picture of the Little Rawhide Creek drainage area just across the street from Mr. Hoy's property.

Figure 11: Little Rawhide Creek at Hoy Property

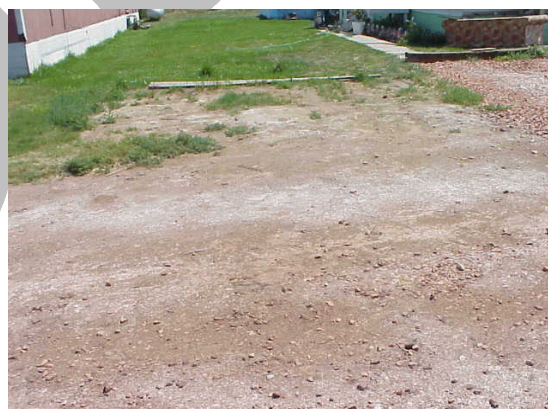
In addition, Mr. Hoy has experienced damage to his home in terms of separation cracks on the roof and wrinkling and warping of the skirting around the underneath portion of the home. These damages coincide with recent movement (settling) of his dwelling. Mr. Hoy has also had to re-engineer his overhead crane and doors in his welding shop due to the decreasing stability of the ground. It is believed that the increased level of groundwater in the subsurface has impacted the shallow sands and silts thus creating unstable conditions and causing structural problems, especially during blasting events at the coal mine that can be felt several miles away. Mr. Hoy has also observed increased amounts of standing water on his property which has caused salt to leach to the surface. Figure 12 shows a picture of the ground where salt has leached to the surface of Mr. Hoy's property.

Figure 12: Evidence of Salt Leaching at Hoy Property
